Loss of 120 VAC Alarm

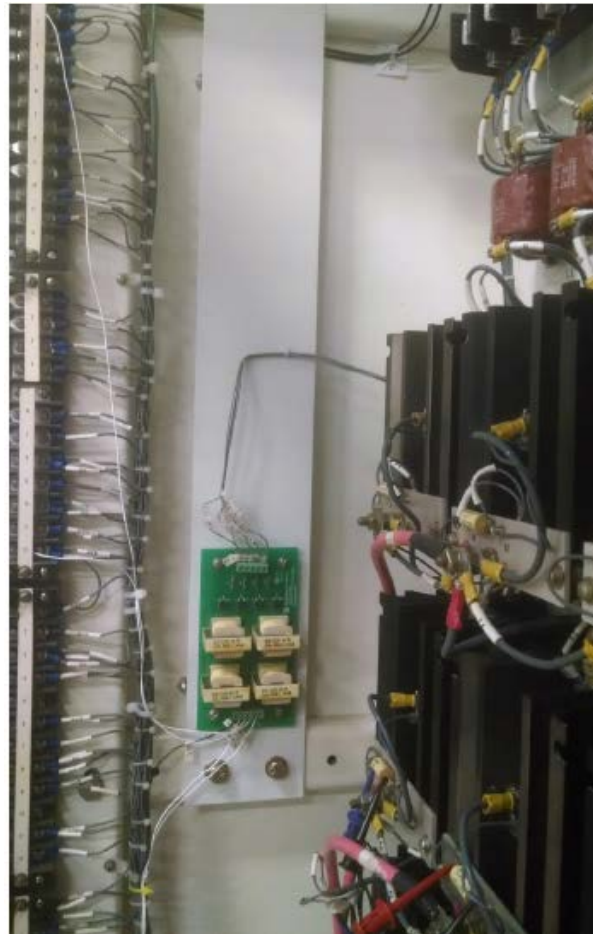
Loss of 120 VAC Modification Installed in Power Cabinet

Westinghouse developed a kit that can be installed in each power cabinet in conjunction with a new alarm card to address the lack of alarm indication and potential for dropped rods. The kit consists of a small transformer assembly that is to be mounted on the sidewall of the power cabinet. The assembly includes a circuit card with four transformers to monitor each of the following signals:

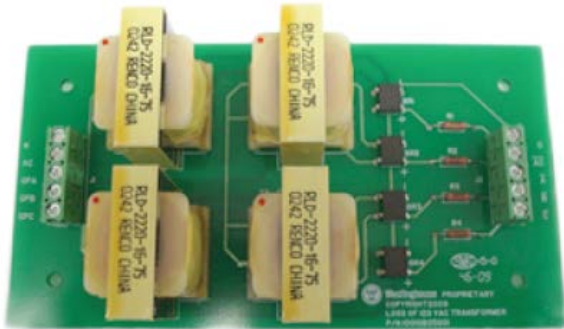
Loss of 120 VAC Transformer Assembly – 10010B05G01

The transformers step down the 120 VAC inputs to 16 VAC, which are then rectified on the transformer assembly to provide 20 voltage direct current (VDC) signals to a new monitoring circuit on a new alarm card.

- Loss of 120 VAC transformer assembly kit 10015B25:
 - One kit is needed for each power cabinet. Each kit consists of a mounting plate with the transformer assembly circuit card attached and all necessary hardware and wire for installation.
- Alarm card 6D31106G01:
 - One alarm card is needed for each power cabinet.
