GEMCO Switches

Description

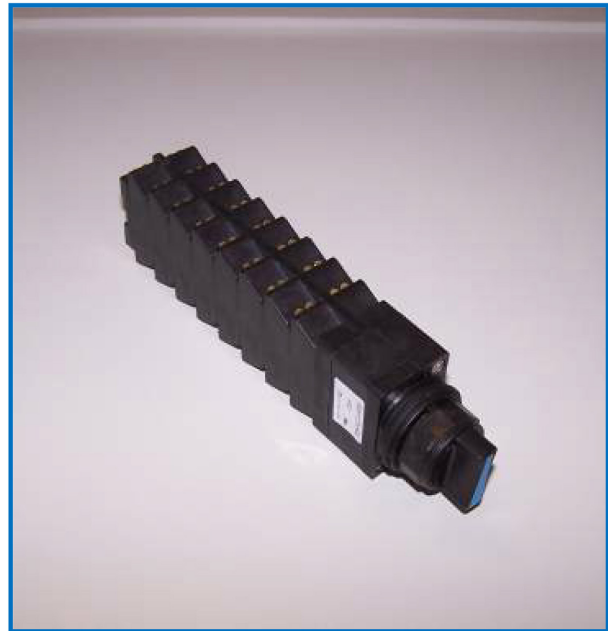
The spring return disks and rotors are now made from stainless steel. The more robust steel pins and disks will function with a lower risk of breakage, a problem that occurred over time with the plastic parts of the Gemco switches.

Westinghouse replacement switch

Because the Westinghouse switches are dimensionally identical to the original Gemco switches, they will fit the existing mounting hole in the module or control panel. The new switches utilize the same type of electrical connection as the original switches, so no re-termination of wiring is required. Once the existing switch has been disconnected from the module wiring and removed using site procedures, the new Westinghouse switch can be easily installed and tested per plant procedures.
