BlueRad™ 5-Sided Fuel Inspection Service

Westinghouse has developed a shielded BlueRad™ 5-Sided Fuel Inspection System designed and built from the ground up to provide the best possible visual examination of each fuel assembly during or after core offload.

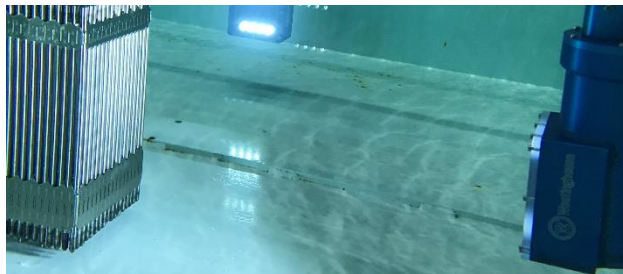
One 5-Sided Camera Viewing Fuel Assembly

The Westinghouse BlueRad™ 5-Sided Fuel Inspection System consists of five high definition BlueRad™ cameras to view each side of the fuel assembly and the bottom nozzle simultaneously. The cameras are mounted to a common custom-made frame and controlled by a simplified controller for easy operation. The inspection can be viewed live and/or recorded for future viewing.

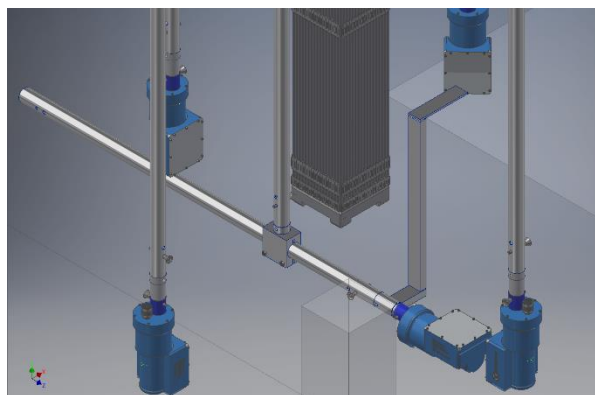
BlueRad™ 5-Sided Fuel Inspection System

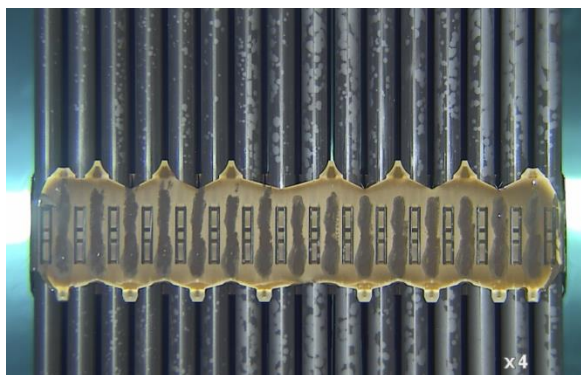
Fuel Assembly Inspection

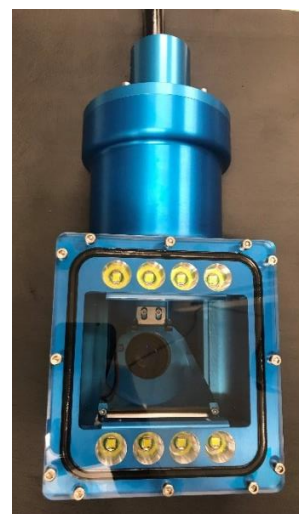
BlueRad™ Shielded Camera

- Five High Definition (HD) tungsten-shielded BlueRad™ underwater cameras to view each side of the fuel assembly and the bottom nozzle
- Simplified custom camera controls and recording software to allow ease of operation during inspection activities
- All-digital, full-HD resolution, for real-time viewing and recording
- Custom telephoto lens allows cameras to be positioned anywhere from 18-50 inches from the fuel assembly
- High intensity LED lighting
- Radiation tolerant up to 2×10^6 R of Co-60 equivalent at 2×10^4 R/hr
- High-speed shutter minimizes motion blur during fuel movement
- Small, lightweight, portable controller
- High definition h.264 video encoding saved in convenient MP4 format, which can be viewed by almost any computer
- Automatic duplication of video to external storage media
- A mounting bracket system custom designed for each plant for quick and easy installation
